**Application:** Pot Line Crane Hook Rotation Gear Boxes

**Product Group:** Sun Hydraulics

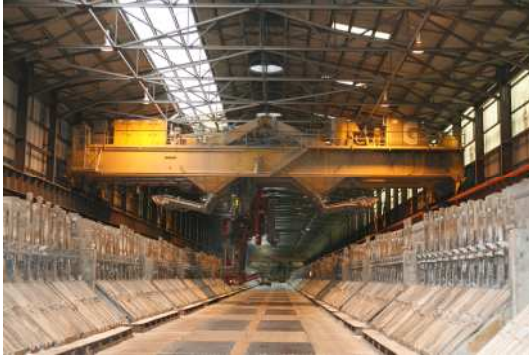
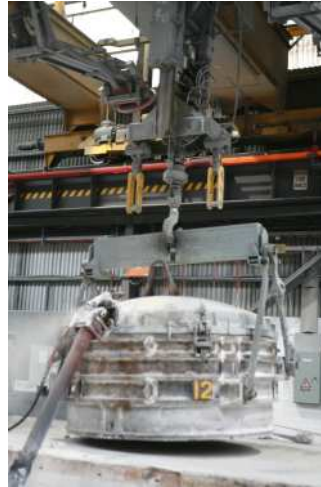
**Summary:** The customer suddenly started breaking the hook rotation gear boxes on the PTA Cranes (increased from 1-2 per year to 1 per month). After talking to the workshop supervisor it was decided problems was probably due to new crane operators changing direction of rotation abruptly thereby causing gear boxes to break.

**Solution:** Fitted Sun Hydraulics dual cross line relief valves to Danfoss hook rotation motors on 3 cranes as trial units. This was a success and the other 5 cranes had valves fitted plus 1 spare for stock (total 9 units supplied).

**Advantages of Solution:** Customer was happy with result and have not had a gear box problem in the last 6 years.
